Manhole Inspection Summary

Manhole # S25GG_022MH

Insp Date: **9/10/07 11:11 AM**

Location Address: **559 ROBERT ST**

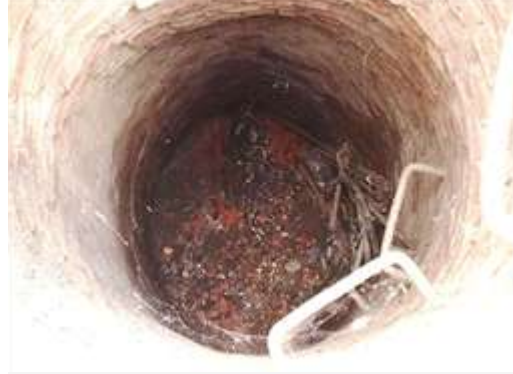
Top View

Corroded steps. Channel debris.

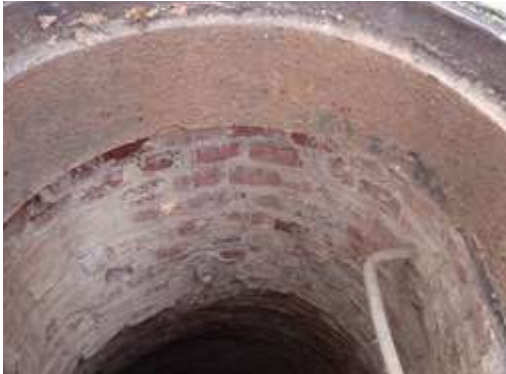
Defect

Frame leaks. Adjustment deterioration and infiltration. Barrel infiltration - other side.

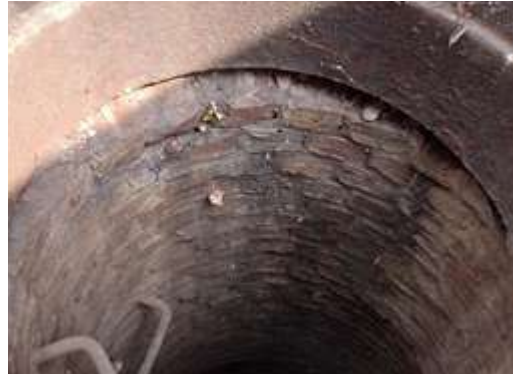
Defect

Frame leaks. Frame offset. Adjustment deterioration and infiltration. Barrel infiltration.

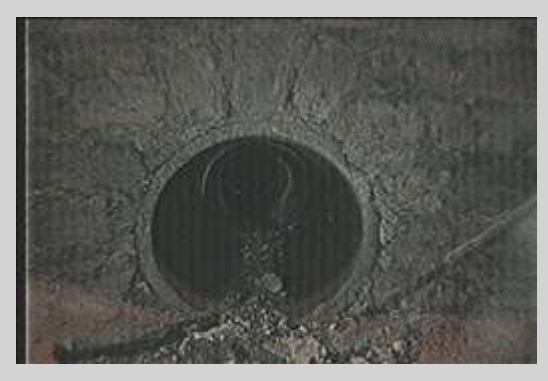
8 in. Circular Gravity Sewer
Pipe Out @ 12 O'Clock

Barrel deterioration and infiltration.
